ROBERT L. BISHOP DAM

DELAWARE COUNTY, NEW YORK
INVENTORY No. NY 534

PHASE I INSPECTION REPORT NATIONAL DAM SAFETY PROGRAM

NEW YORK DISTRICT, CORPS OF ENGINEERS
MAY 1981

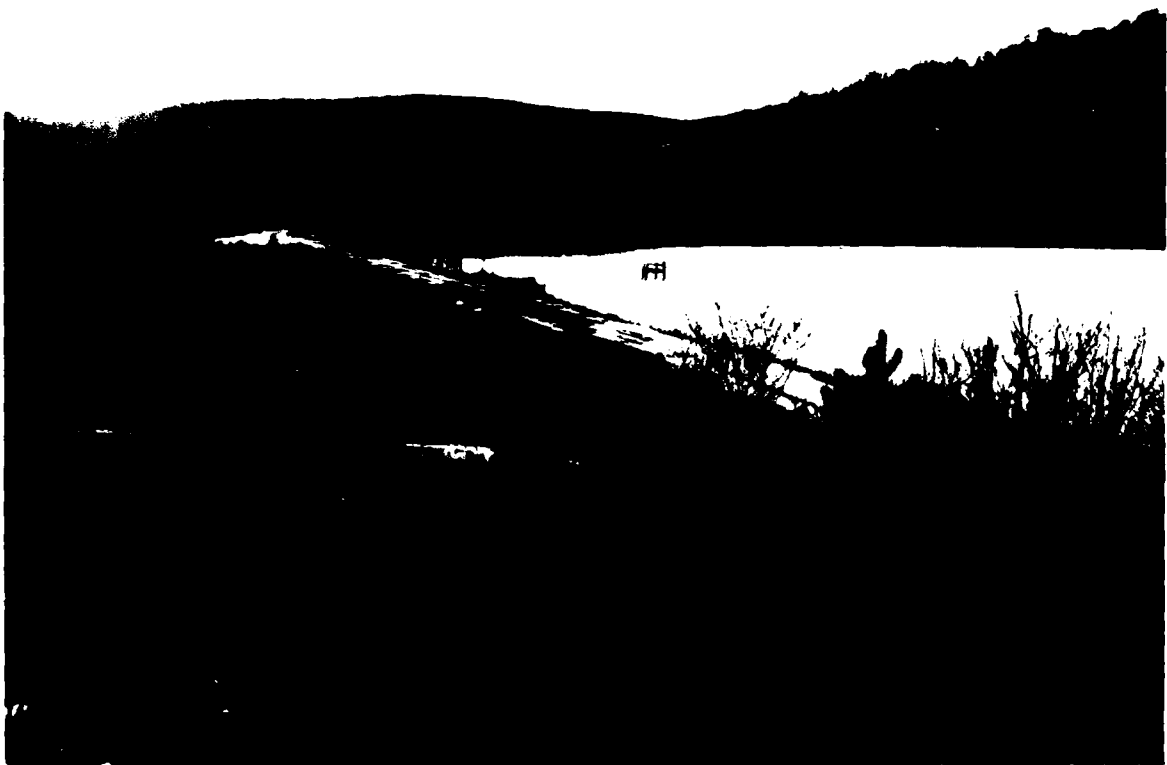
PHOTO #1: Overview of
Robert L. Bishop Dam
Inventory No. NY 534

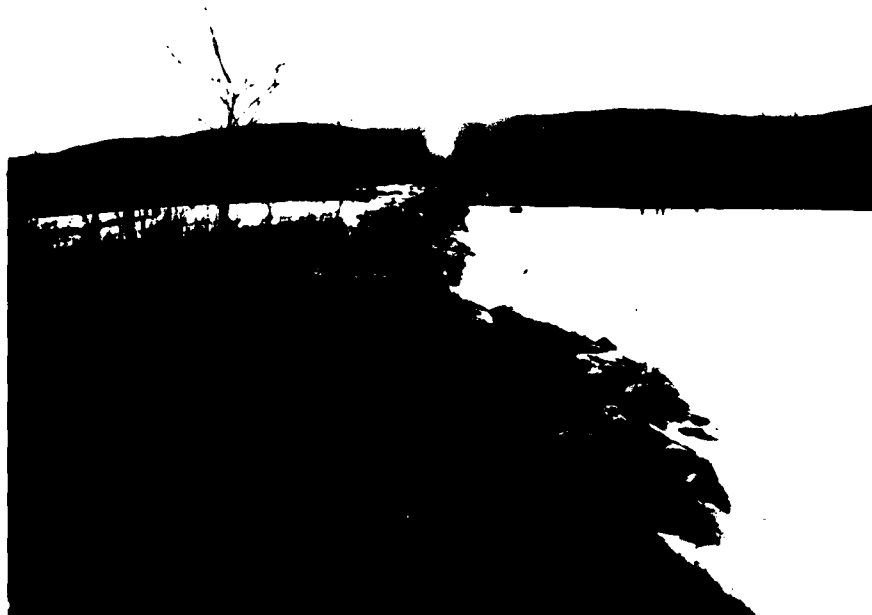
5. Both the riprapped upstream slope (above the reservoir level) and the grassed downstream slope have a minor cover of thick brush and small trees throughout (See Construction Photo No. 1 and Photos No. 4, 5, 6 and 7). Occasional small diameter animal burrows

PHOTO #6: Upstream face of dam
